BLACKSTONE RIVER BASIN
GRAFTON, MASSACHUSETTS

FISHERVILLE POND DAM
MA 00577

PHASE I INSPECTION REPORT NATIONAL DAM INSPECTION PROGRAM

OCTOBER 1978

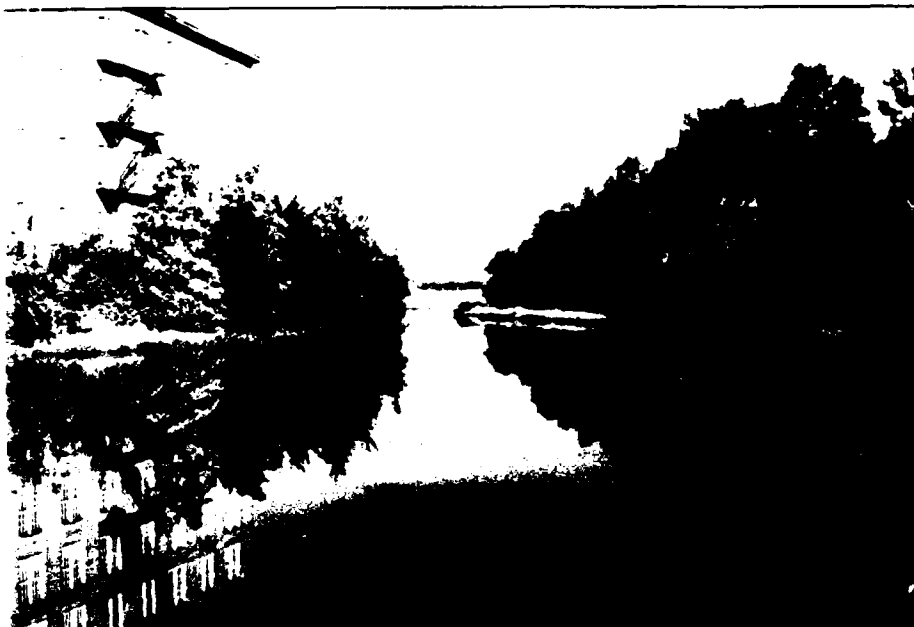
**NO. 7 VIEW OF BLACKSTONE RIVER
DOWNSTREAM OF SPILLWAY**

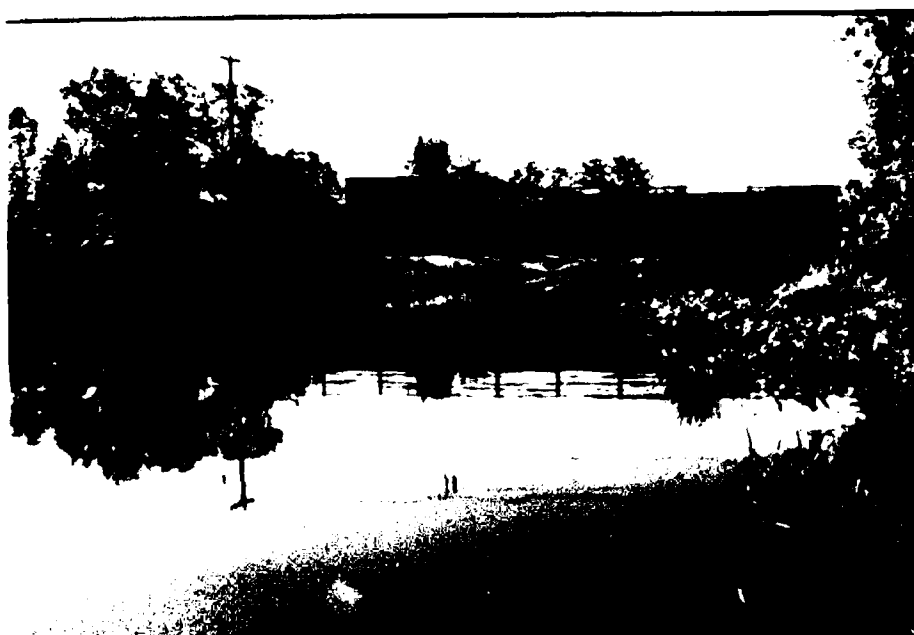
**NO. 8 VIEW OF MAIN STREET BRIDGE
OVER BLACKSTONE RIVER**
